**FINAL REPORT
MAY 2004**

REPORT NO. 04-01

**TRANSPORTABILITY TESTING OF THE MARINE CORPS
HIGH MOBILITY ARTILLERY ROCKET SYSTEM (HIMARS)
RESUPPLY VEHICLE (RSV) AND RESUPPLY TRAILER (RST),
TP-94-01,
"TRANSPORTABILITY TESTING PROCEDURES"**

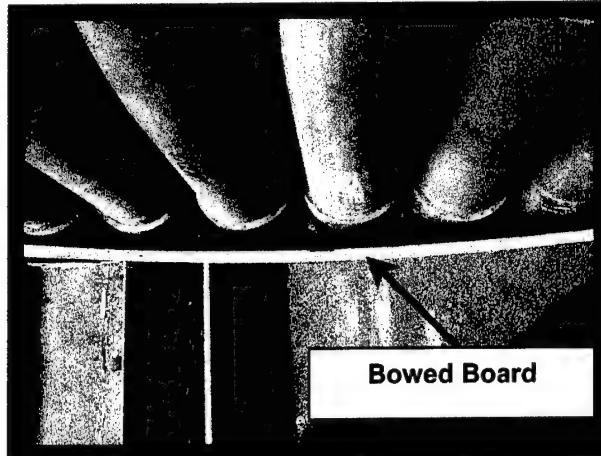
Photo 12. Bowed Dunnage Assembly

4. Following Impact #4 the projectiles on the truck and trailer moved in the direction of impact an additional 0.125 inches (toward the rear of the truck and trailer). The dunnage assembly on the rear of the trailer bowed (See Photo 12). The shoes on the truck and the trailer helped restrain the payload and dunnage assembly.
